**MERRIMACK RIVER BASIN
WOLFEBORO, NEW HAMPSHIRE**

**CRESCENT LAKE DAM
NH 00309**

**PHASE I INSPECTION REPORT
NATIONAL DAM INSPECTION PROGRAM**

OCTOBER 1978

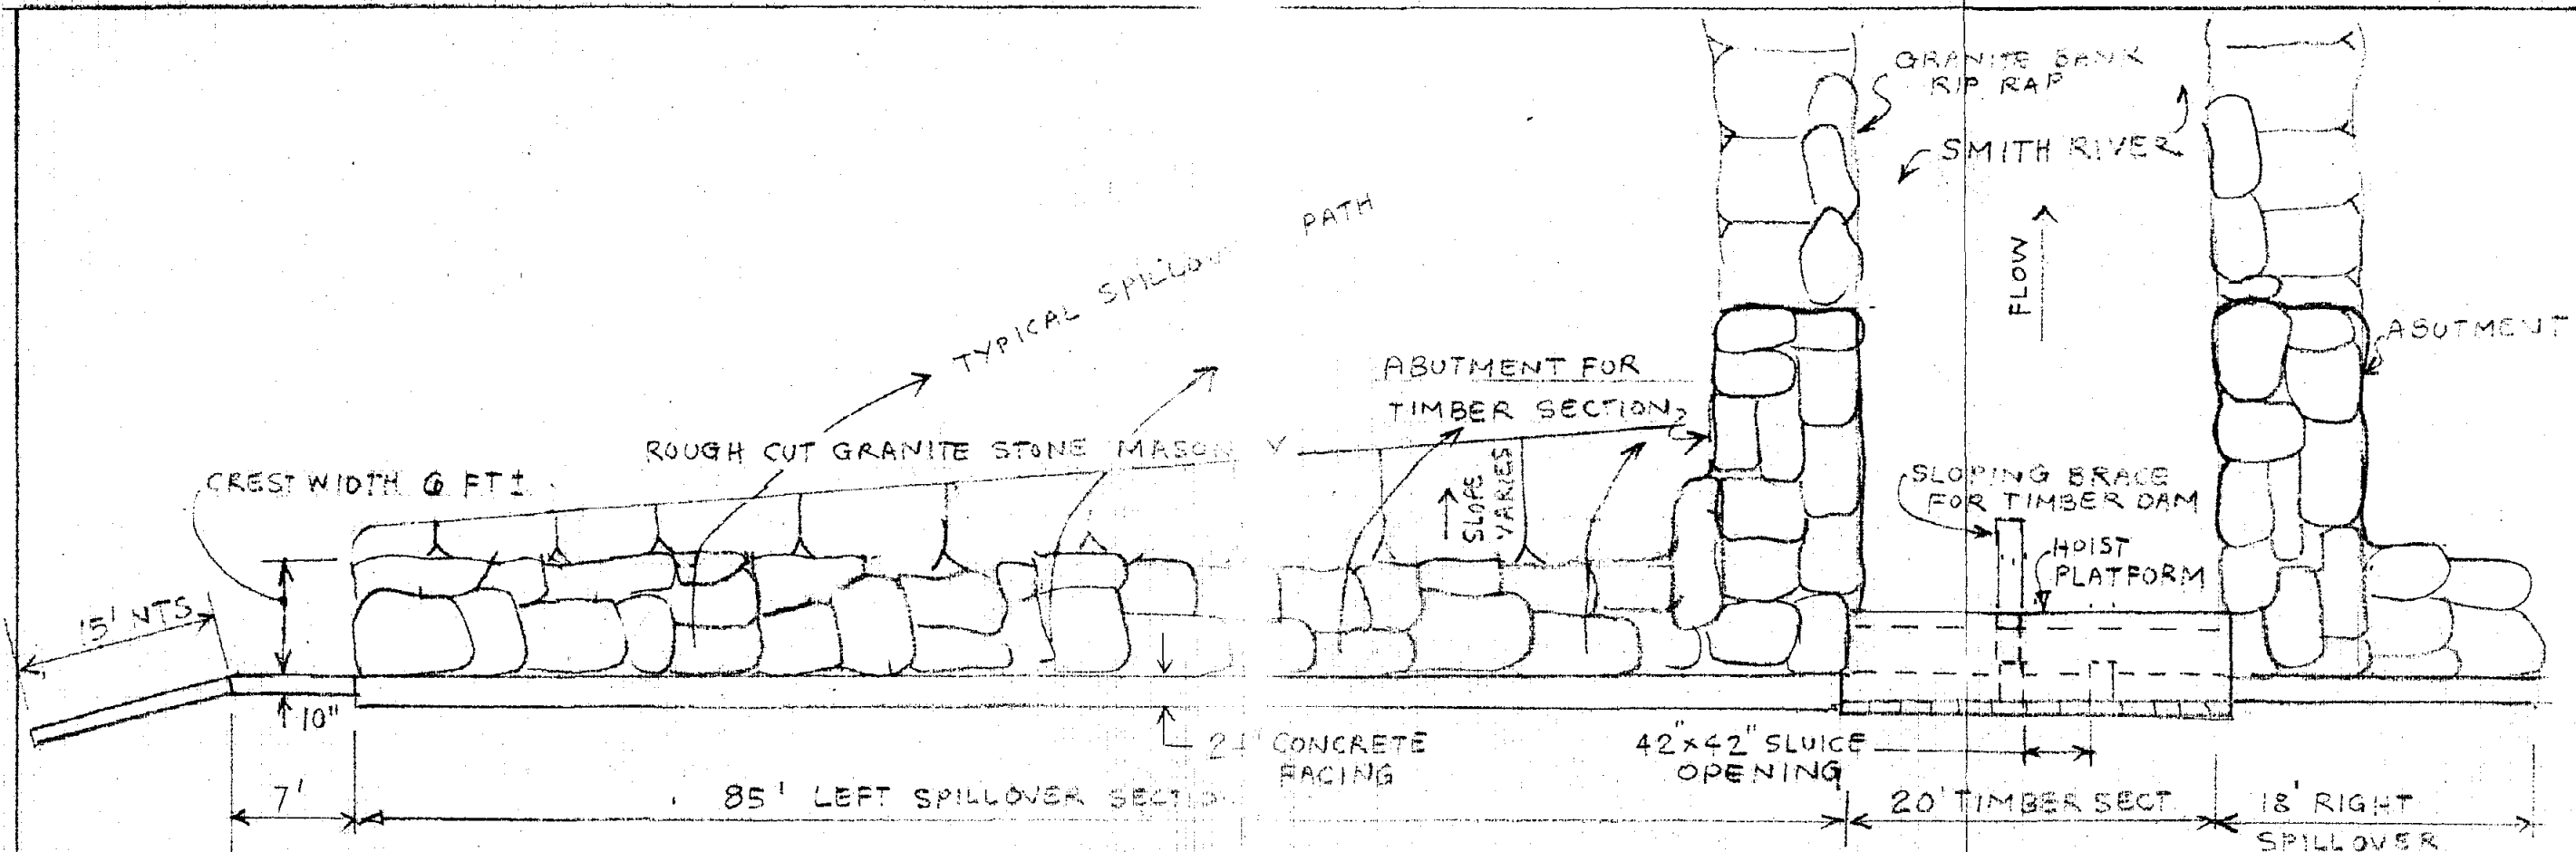
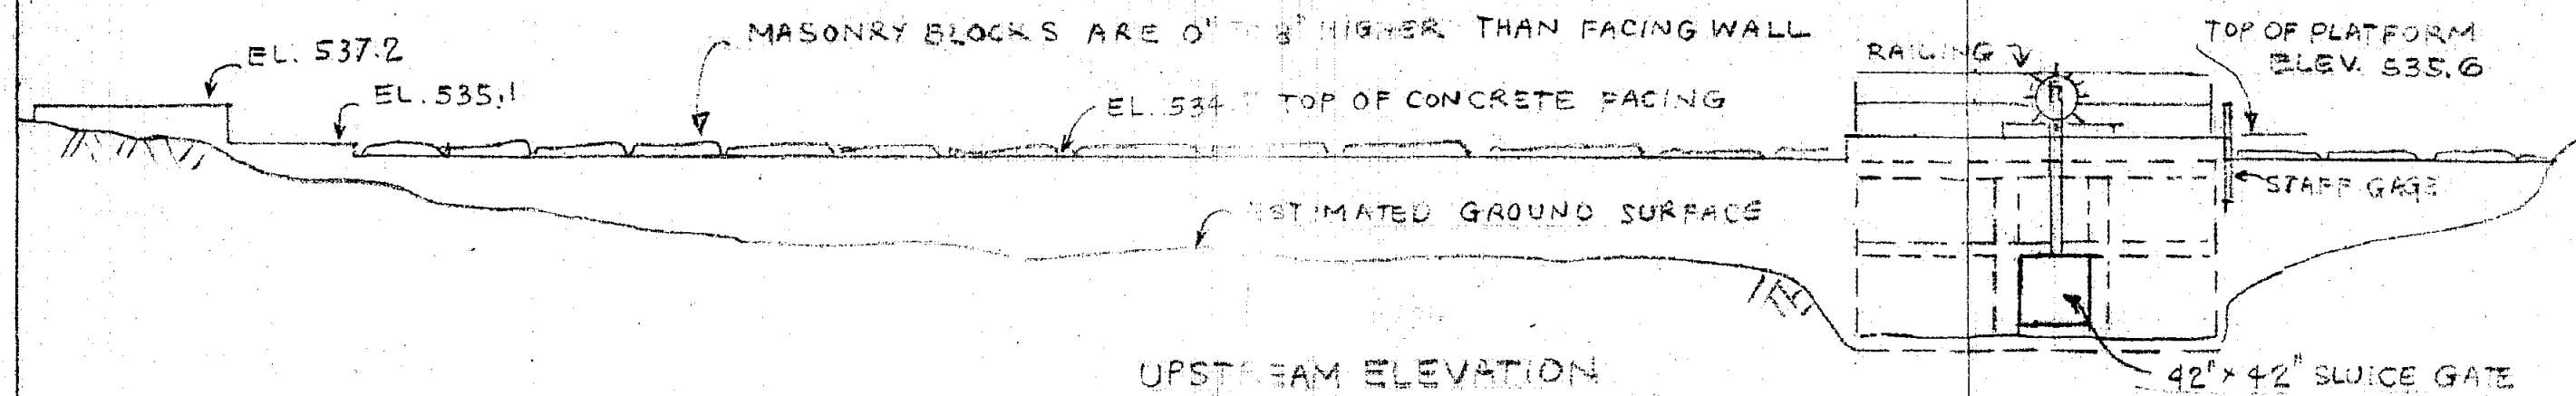
HARRIS-ECI ASSOCIATES		
CRESCENT LAKE DAM		DWG.
FIELD INSPECTION SKETCH		2

The timber dam section spans between the two massive masonry abutments described above. Details of the timber dam have been sketched during the field inspection and are reproduced in Drawing 2. The current timber section was rebuilt in the 1950's and utilized salvaged bridge timbers from an abandoned railroad line. The current arrangement of timber structural members is said to follow the previous design. All timbers appear to be in serviceable condition. A log sluice opening in the timber dam has been ineffectively sealed up and is leaking a considerable volume of water estimated at 50 gpm, (see Drawing 2).
